WATERSHED WORK PLAN
**PERILLA MOUNTAIN
WATERSHED**
COCHISE COUNTY, ARIZONA

Watershed Work Plan *Perilla Mountain Watershed*

Cochise County, Arizona

April 1970

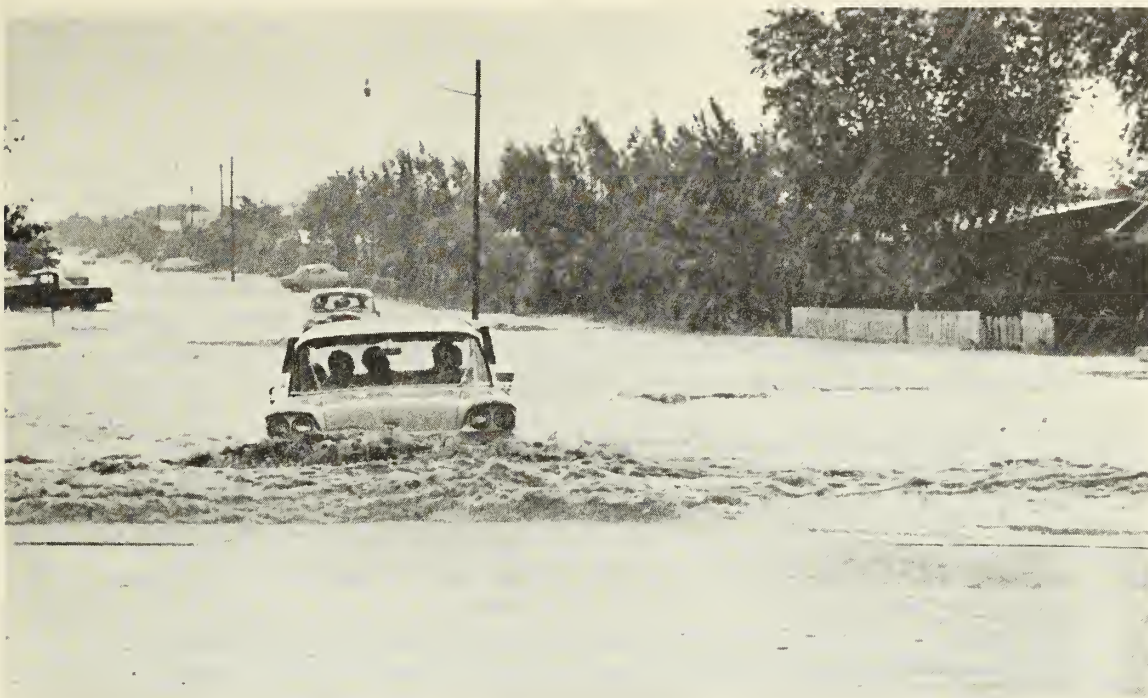
Cars forge through floodwater at 5th St.
and Pan American Ave. August 3, 1967
Photo - Courtesy of City of Douglas

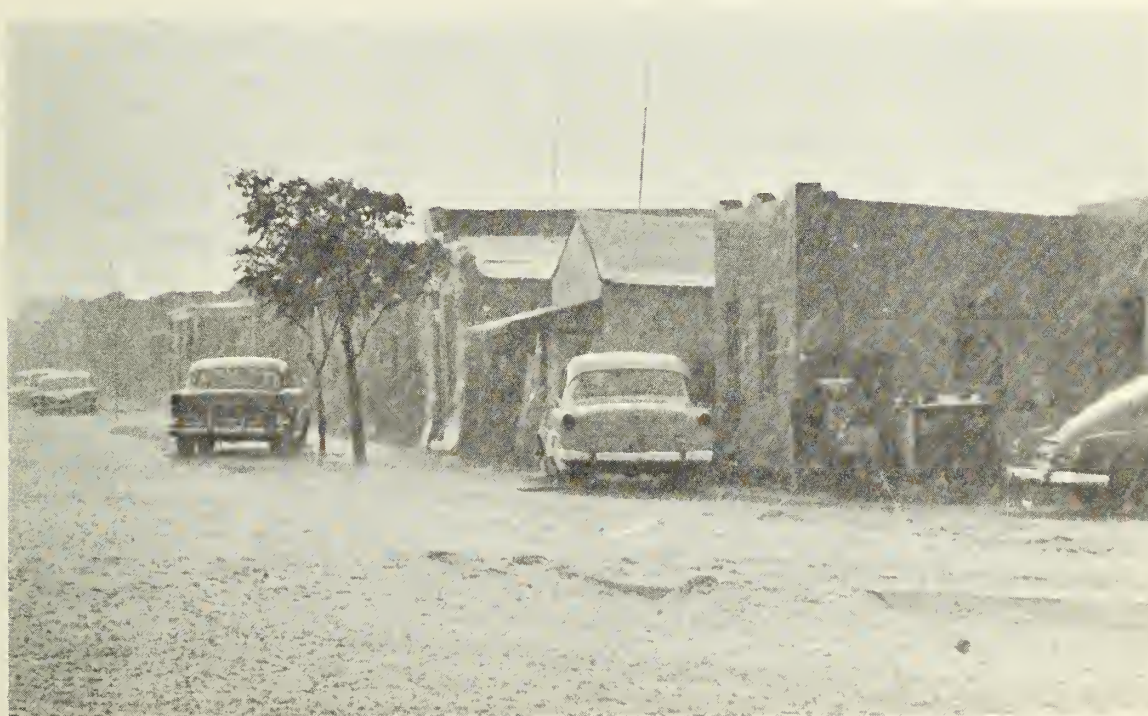
Flooding at 6th St. and Pan American Ave.
August 3, 1967
Photo - Courtesy of City of Douglas

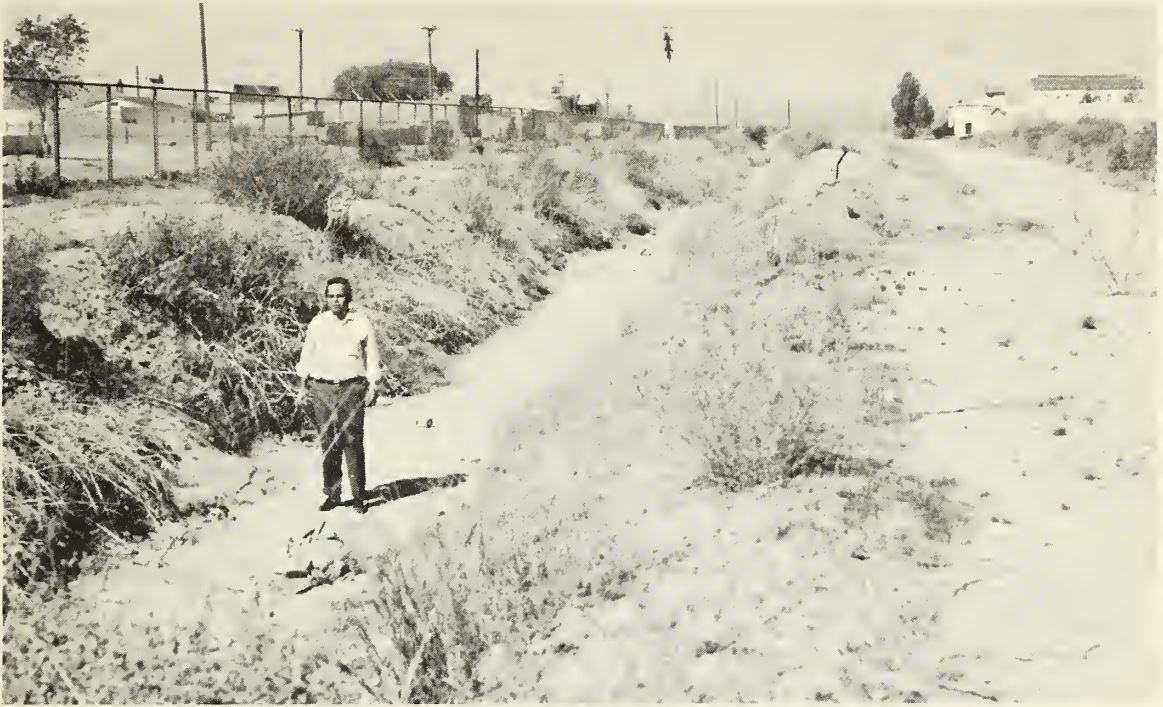
Flood channel along side of International Ave.
SCS PHOTO 2-792-1

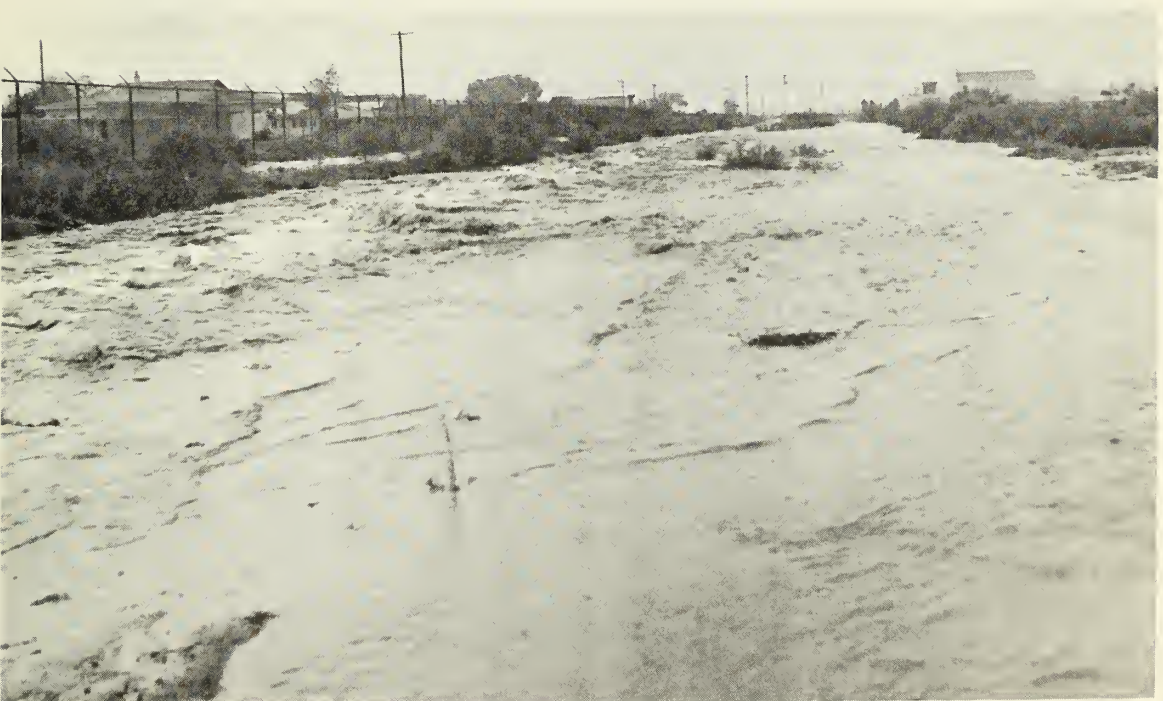
Sediment laden floodwater rushing down
International Ave. July 29, 1964.
Photo - Courtesy of City of Douglas
